OBJECT MARKERS AT NARROW BRIDGES ON LOW VOLUME RURAL HIGHWAYS

MBTC FR-1083

Margaret Rys, Rajasekhar Pudi, and Robert Stokes

Final Report

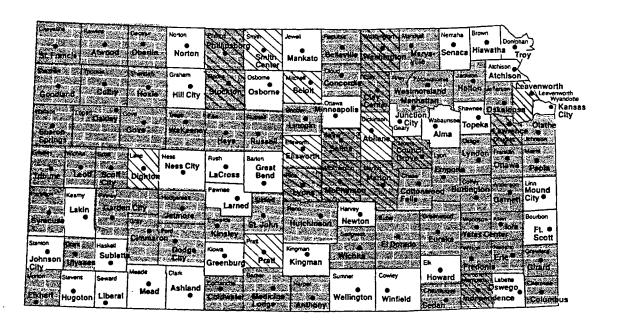
Figure 1. Distribution of Survey Responses in Kansas.

Seventy-four county highway officials from 64 counties responded to the survey (see Figure 1). Tables 1 and 2 provide summaries of the survey results. Table 1 summarizes the responses to questions concerning the definition of a "narrow" bridge, the type(s) of object markers used on narrow bridges, the type(s) of posts used to mount object markers at narrow bridges and the season of the year when problems with large farm vehicles on narrow bridges are most prevalent.

attended the meeting. As shown in Figure 1, most of the respondents were from North, East and Central Kansas. Table 3 summarizes the results of the survey of Kansas farmers.

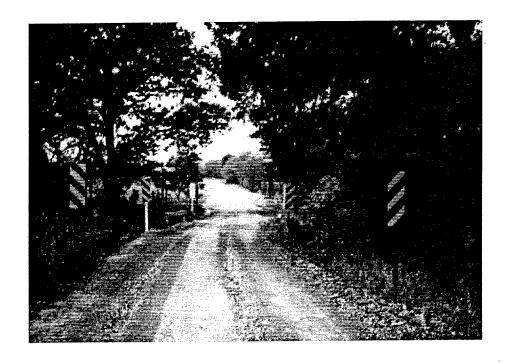
Figure 2 shows object markers consisting of both flexible posts as well as staggered steel "U" channel posts. When rigid posts are used to support object markers on narrow bridges, it is essential that the posts be staggered to allow wide farm equipment to maneuver between the markers.

Figure 2. Staggered object markers mounted on steel "U" channel posts as well as flexible carsonite posts.

Several counties in Kansas currently use flexible sign supports for object markers on bridges and culverts on low volume rural roadways (See Figures 2 and 3). These flexible supports have the advantage of allowing markers to be placed in accordance with MUTCD specifications while still allowing wide vehicles to pass over them. The problem with flexible supports is that cutter bars and other protrusions on wide vehicles may "snag" the lower edges of the object marker and damage and/or "uproot" the object marker and its support (see Figures 3 and 4). Some county highway officials also indicate that high wind loads can cause considerable deflection and "flapping" of the object markers. This problem is especially pronounced when object markers are mounted on both sides of the flexible support, as in the case of staggered installations. A variations on the idea of flexible supports is the spring loaded impact recovery system (Figure 8).

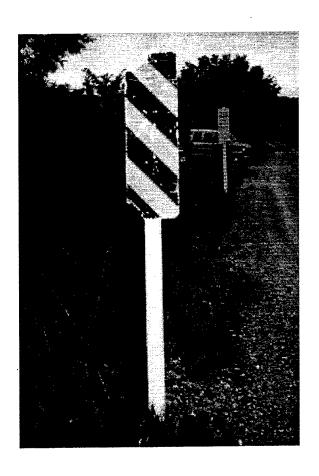
Figures 3 through 5 illustrate various types of damage to object markers observed during the field visits. As shown in Figure 3, the most prevalent type of damage observed in the field were scratched faces and broken corners on the object markers. The scratched faces on the object markers is a concern because of the reduced reflectivity that results from such damage. The broken/damaged lower corners is probably due to agricultural equipment cutter bars, etc. "snagging" the sign edge. In some cases, snagged cutter bars, etc. may actually pull the sign post/support out of the ground (see Figure 4).

Figure 3. Object marker with scratches on the face and broken corners.

The broken corners on the upper edges of the object markers may be due to the sign being crushed against the bridge railing as the equipment passes over the deflected flexible post and/or by striking the equipment when the deflected sign springs back to a vertical position after the farm equipment passes over the object marker/post. Damage caused by the sign being crushed against the bridge railing as the equipment passes over the deflected flexible post is apparent in Figure 5. In this case the object marker has been installed too close to the bridge railing. As the sign post deflects, the upper portion of the sign/post comes in contact with the bridge railing and may suffer damage in the form of

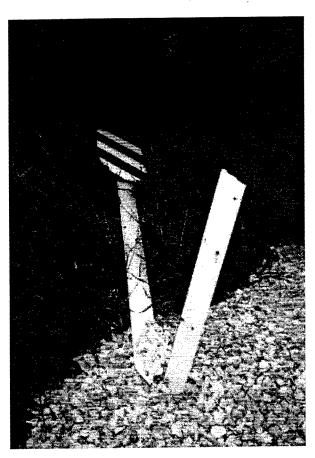
Figure 4. Object marker lying on the ground with broken post.

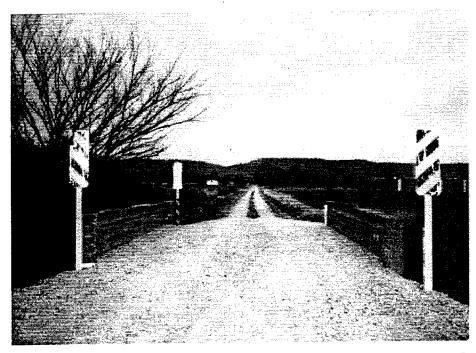
broken corners (see sign on near left side of Figure 5) or a sheared sign support (see broken post on far right side of Figure 5).

Figure 5. Object markers with damaged corners, scratched faces and broken post.

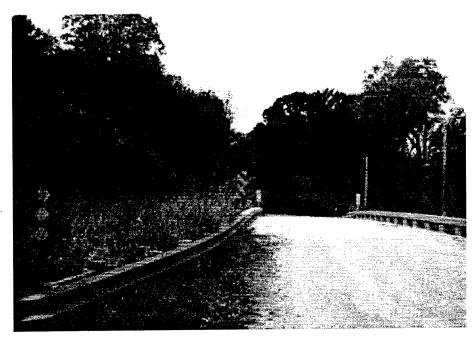
Figure 6: Object Marker partially obscured by vegetation.

Some operators of large farm equipment have suggested that simply lowering the height of object markers would eliminate much of the problem. However, lowering the height of object markers by mounting the markers on the face of bridge railings or by reducing the height of sign supports greatly reduces their visibility. Object markers mounted on the face of bridge railings can become obscured by mud splatters and object markers on shortened sign supports can become obscured by vegetation (see Figure 6).

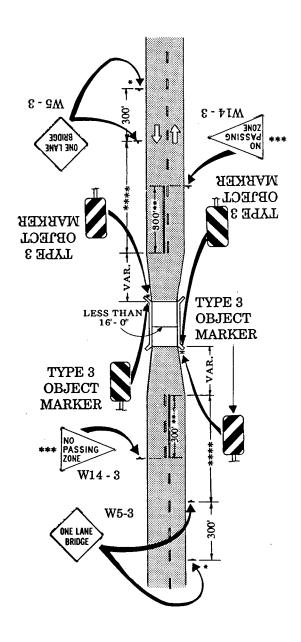
Another means of accommodating wide vehicles on narrow bridges is to stagger the object markers. This practice consists of mounting object markers on both sides of single posts positioned on the right side of each approach (See Figure 7). This arrangement allows wide vehicles to clear the object markers by steering to the left on the approach to the bridge and then steering to the right as they exit the bridge. However, some farmers indicate that many bridges are too narrow and/or too short to allow them to maneuver around the object markers without striking the bridge railing.

Figure 7. Type 3 Object markers on both sides of the single post positioned on right side of each approach.

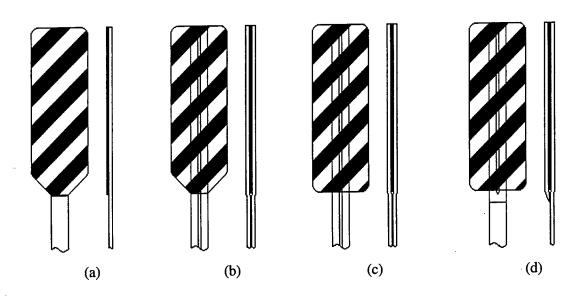
The field observations indicate that the lateral spacing of object markers installed in accordance with the MUTCD does not allow sufficient clearance for many types of wide farm equipment. As a result, object markers need to be either staggered, mounted at a reduced height or mounted on flexible supports. In the case of object markers mounted on flexible supports, the most common types of sign damage observed in the field were broken or bent sign corners and scratched sign faces. This damage to the lower sign corners and the scratched sign faces appears to be the result of the equipment "snagging" on the lower edges of the sign face and dragging over the sign face. In the case of damaged upper sign corners, the damage appears to result from installing the sign supports too near the bridge railing. In such situations, the upper edges of the sign can be crushed against the railing as large vehicles pass over the deflected sign/support. A simple and inexpensive means of preventing vehicles from snagging the lower sign edges might be to angle the edges as illustrated in Figure 9(a). The I-beam shape of the typical flexible support could serve as a channel to guide the farm implement protrusions (cutter bar teeth, etc.) over the surface of the sign face. In the case of staggered installations, the sign face could be "sandwiched" between two flexible supports (Figures 9(b), 9(c) and

Figure 9. Alternative Sign/Support designs.
